HURRICANE SANDY

2013 Annual Building Inspection Engineering Conference

National Academy of Building Inspection Engineers

John C. Cronin, Jr., P.E., SECB, CBIE, F.NABIE

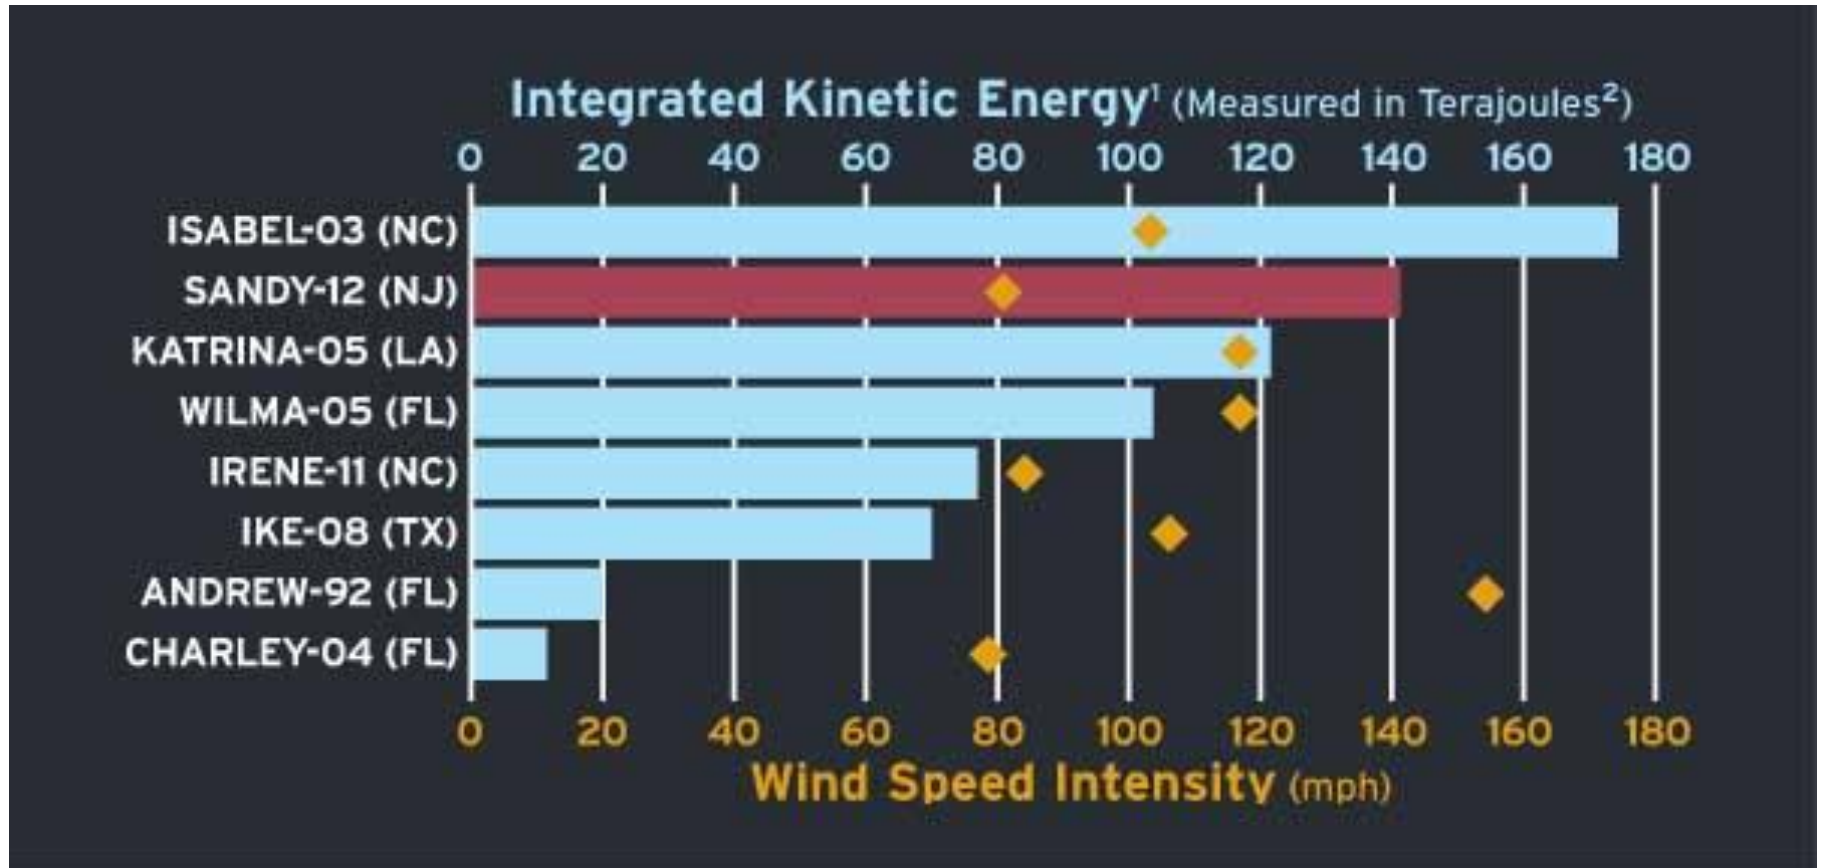
1. Energy of storm based on extent of tropical storm-force winds
2. One terajoule = 277,777 kWh = energy used by 296 homes in one month

The most powerful storms are not necessarily the windiest. The energy in Sandy was equivalent to the power used by 41,440 U.S. homes in one month.

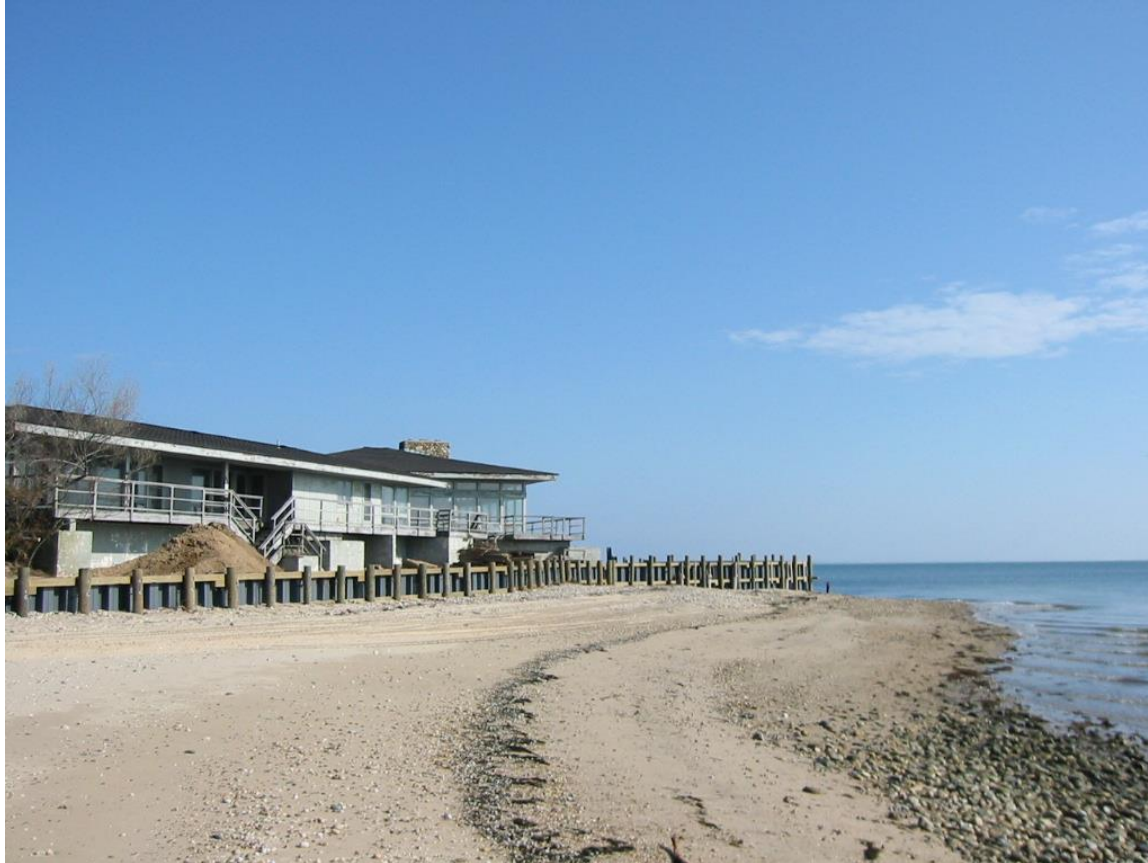
Northeast facing home on beachfront

This home had a relatively new bulkhead in place prior to the storm.

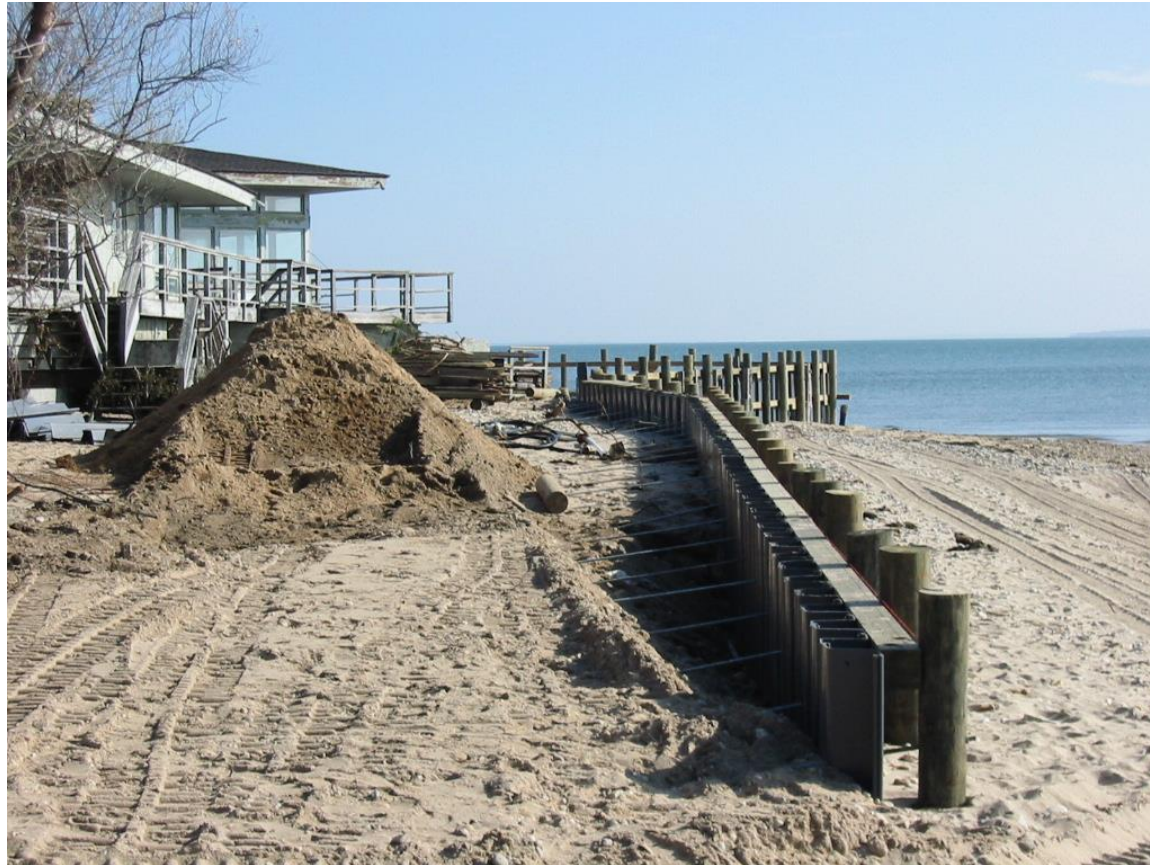
Newly reconstructed bulkhead, post storm

A repair and replacement for the damaged bulkhead was secured relatively quickly. The end of the bulkhead closest to us had been swept away, with debris deposited on a point of land far to the right. It is doubtful this repair will be any better than what was lost.

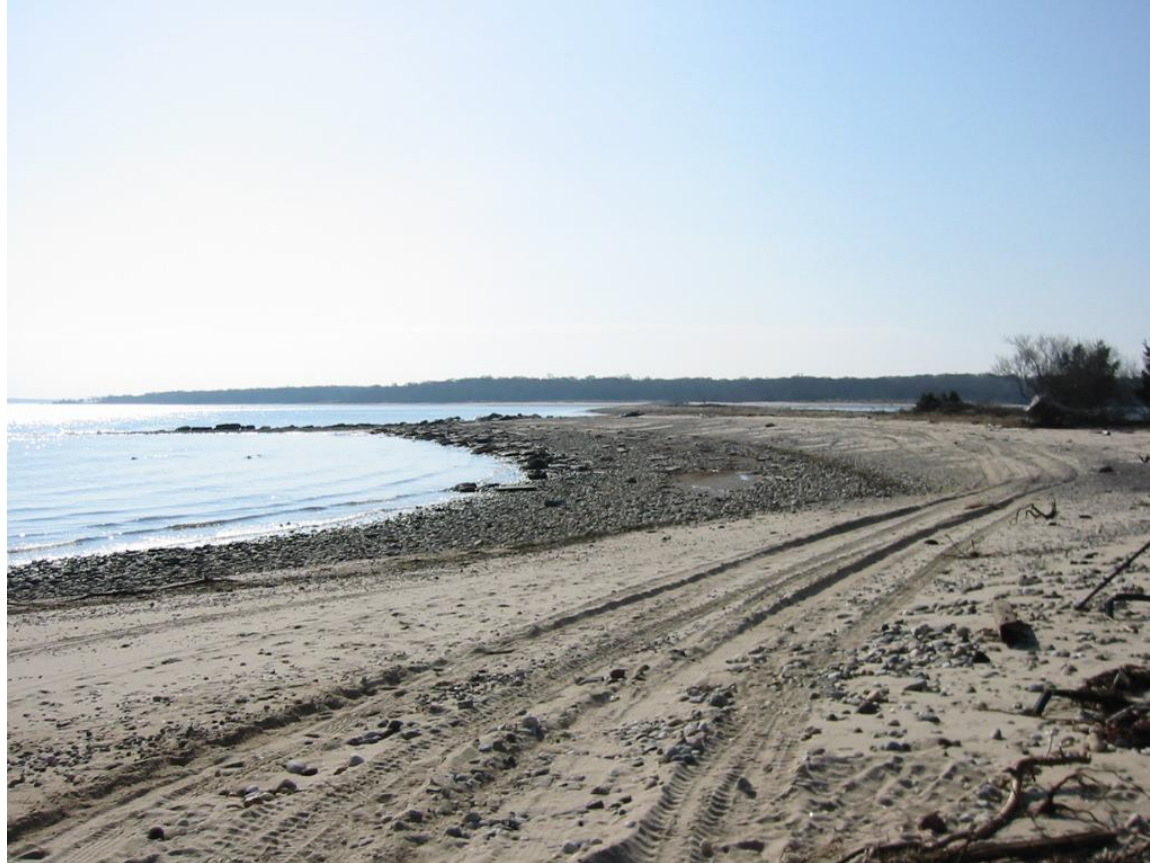
This is the point of land discussed in the previous slide

This land feature is actually a protective spit that terminates in an inlet into a harbor in about the middle of the photo. The spit forms a barrier to the harbor to the left. Storm surge effects nearly breached this barrier beach.

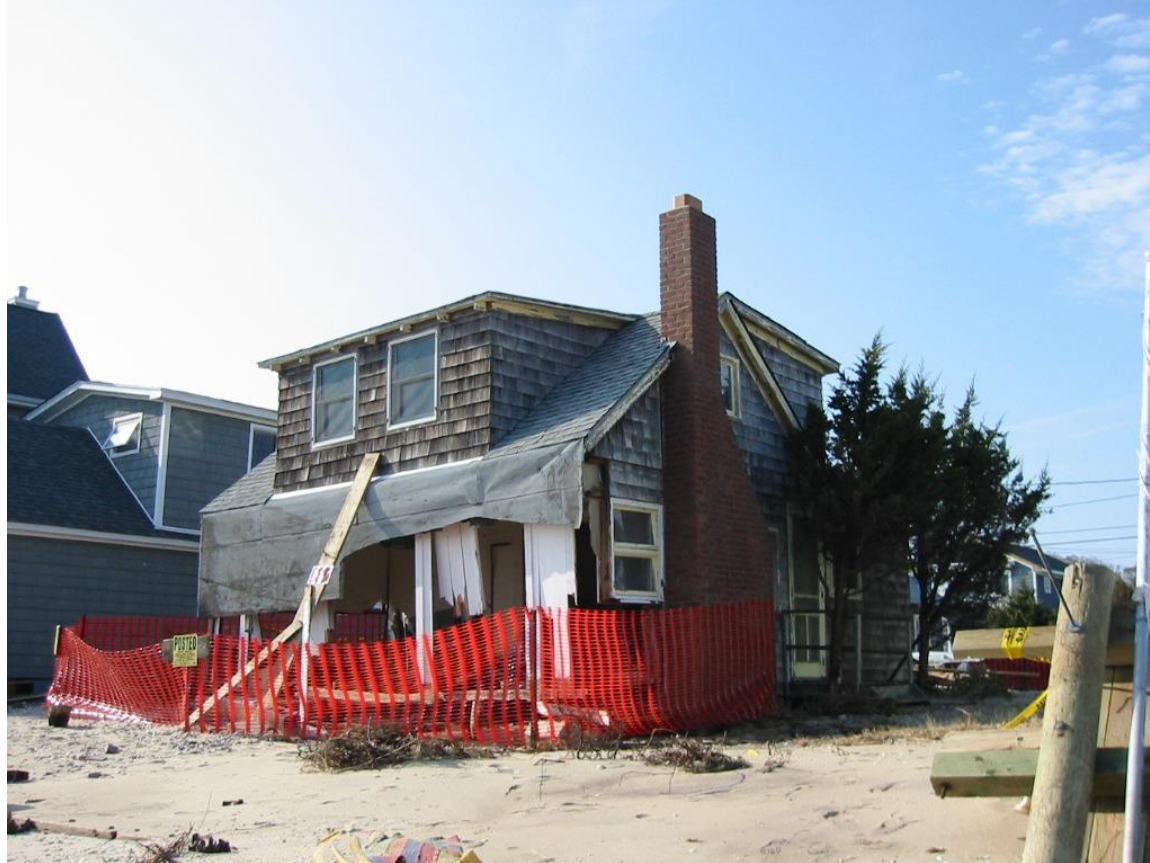
Waterfront home in East Marion, Long Island, NY

The rear portion of this house was virtually demolished, and much of the first floor interior was heavily damaged. The second floor was largely unaffected although the building was structurally compromised. The home was a total loss.

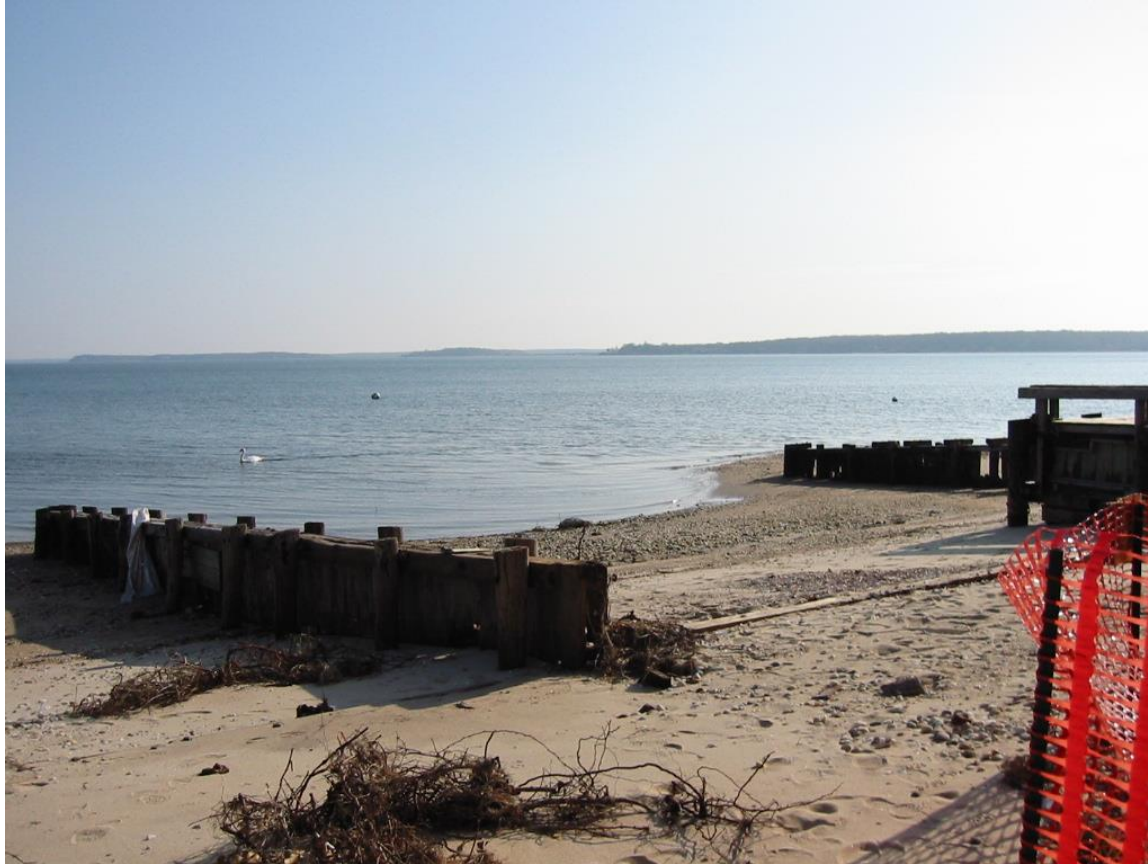
Shorefront behind the previously shown home

Although groins remain in place, the bulkhead behind the house was effectively washed away.

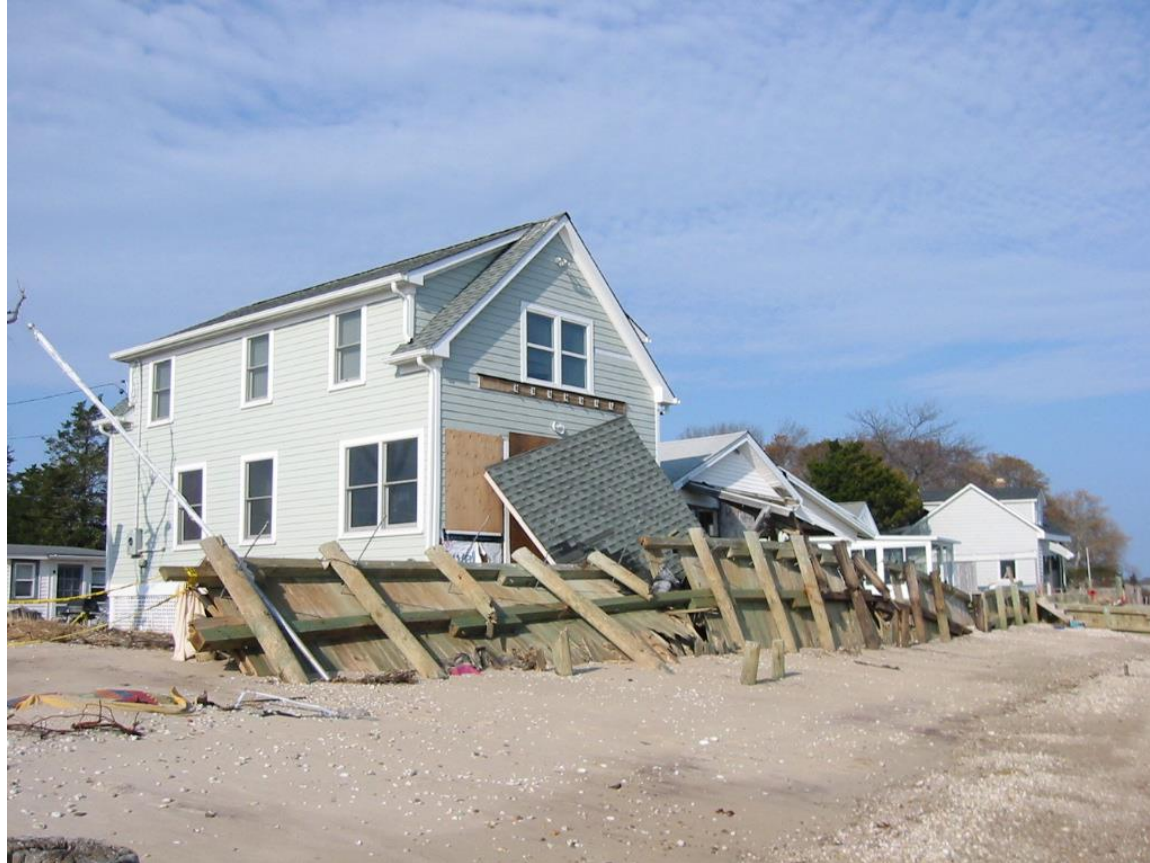
This home is immediately east of the previous

This residence, though damaged, survived the onslaught because it was built to newer and more stringent requirements in the NYS Building Code. However the back porch roof and the bulkhead were destroyed.

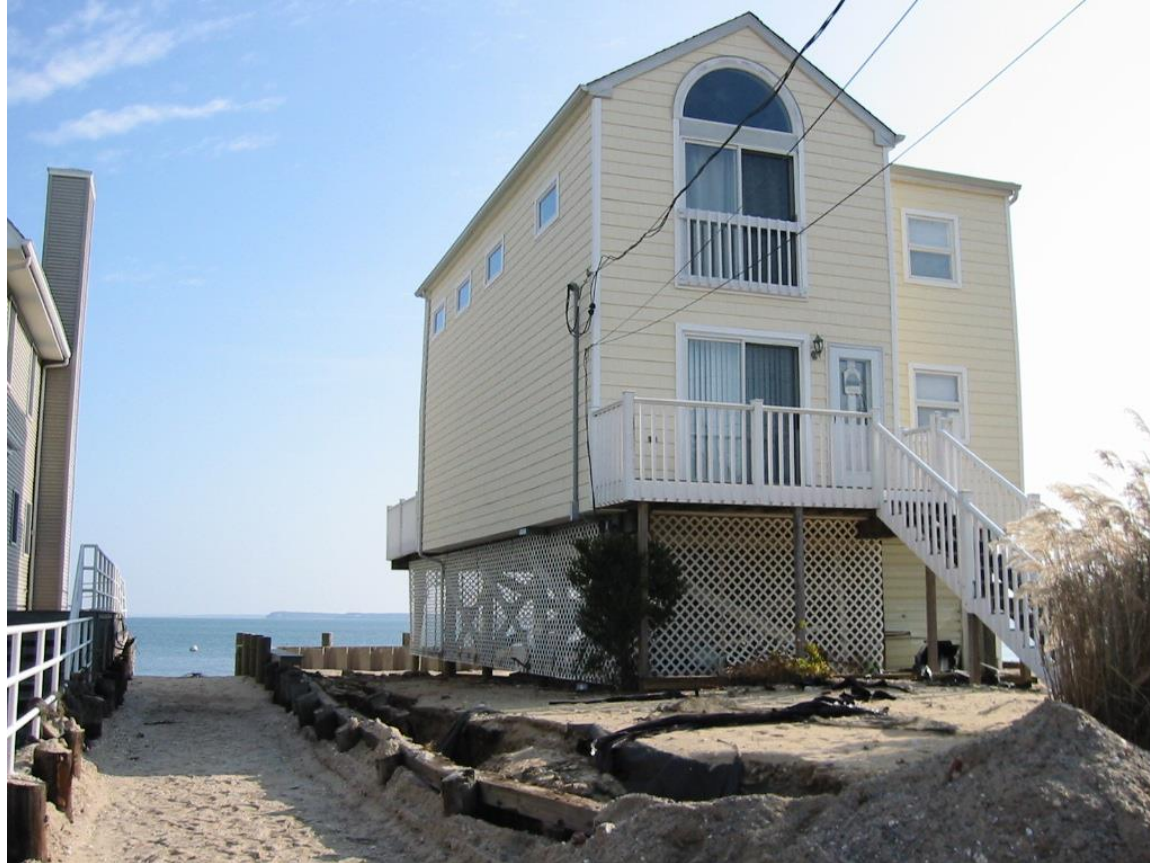
Another home in the same area

This home also survived the storm with minimal damage. It too was built to the more robust requirements in the NYS Building Code.

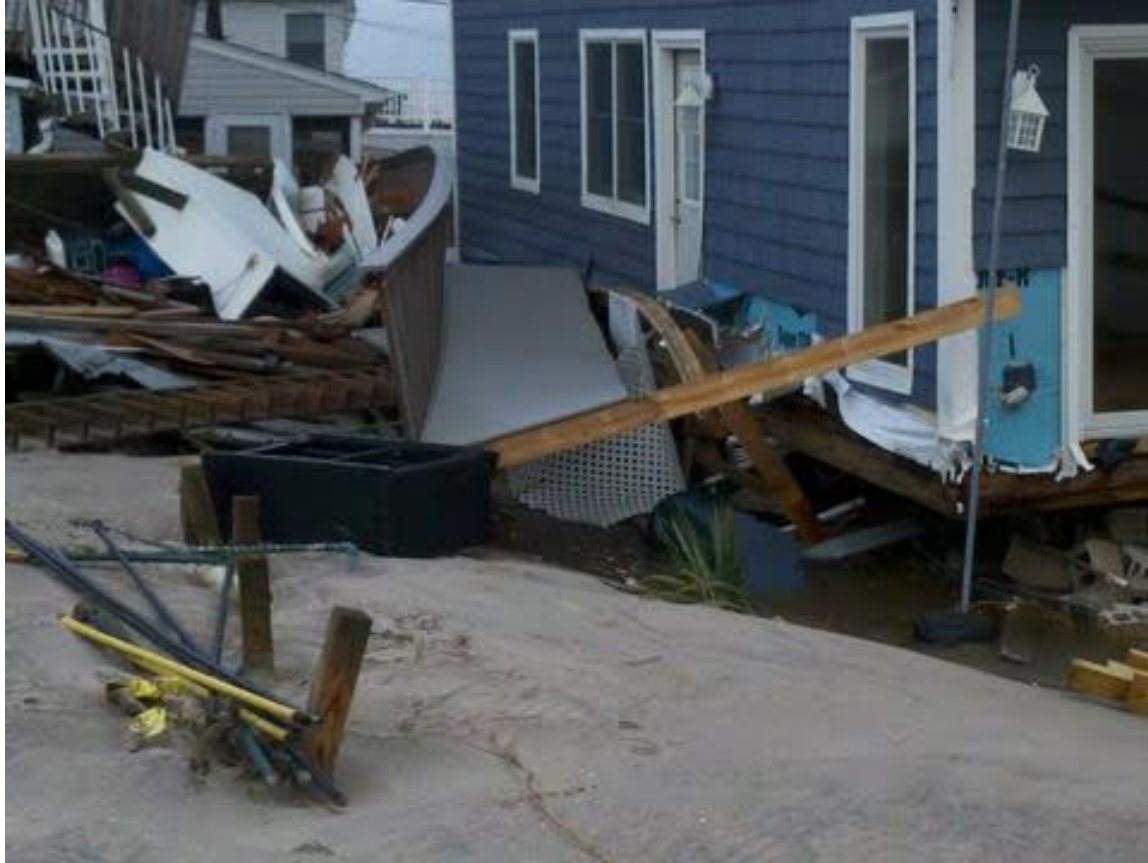
Damaged home in Breezy Point, Queens (NYC)

Note the displaced concrete blocks from the foundation, at the lower right.

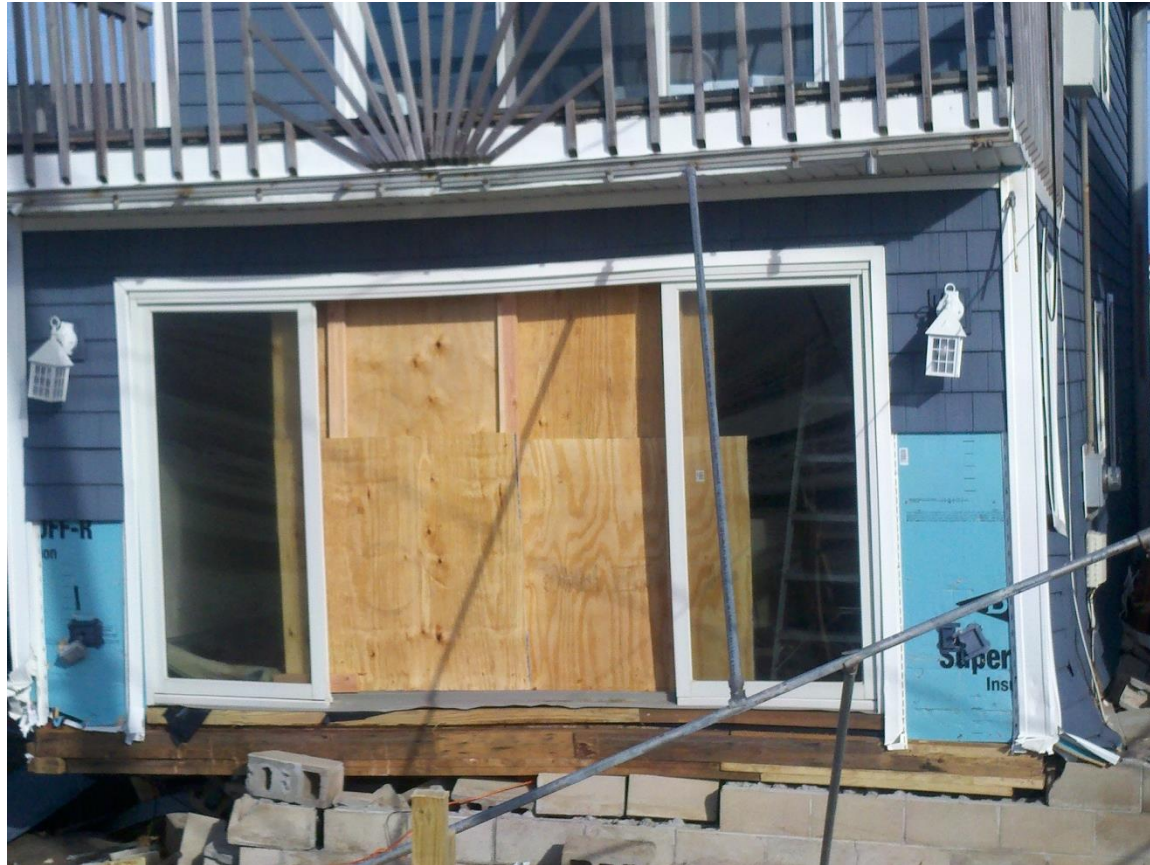
Same house

Displacement from, and damage to, foundation is apparent. Newer code requirements address this issue.

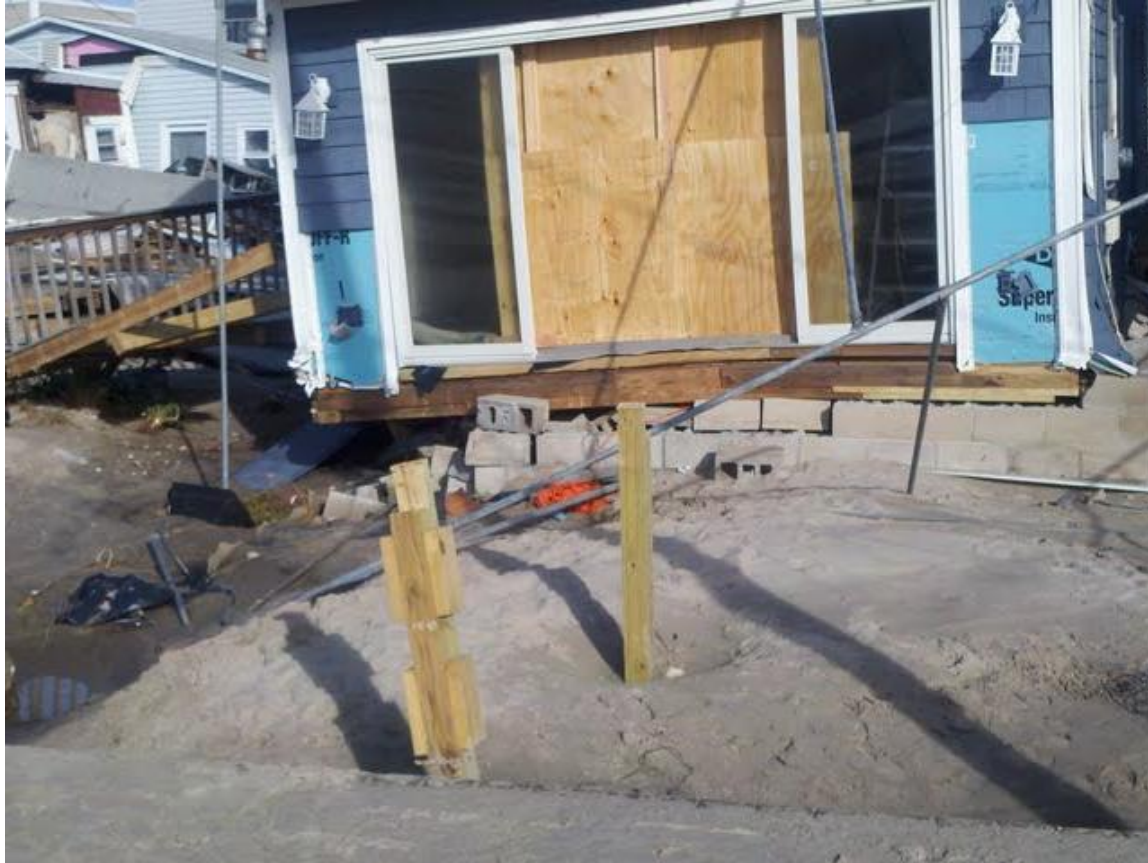
Another view of the same residence

This photo better illustrates the pronounced movement of the building off the foundation.

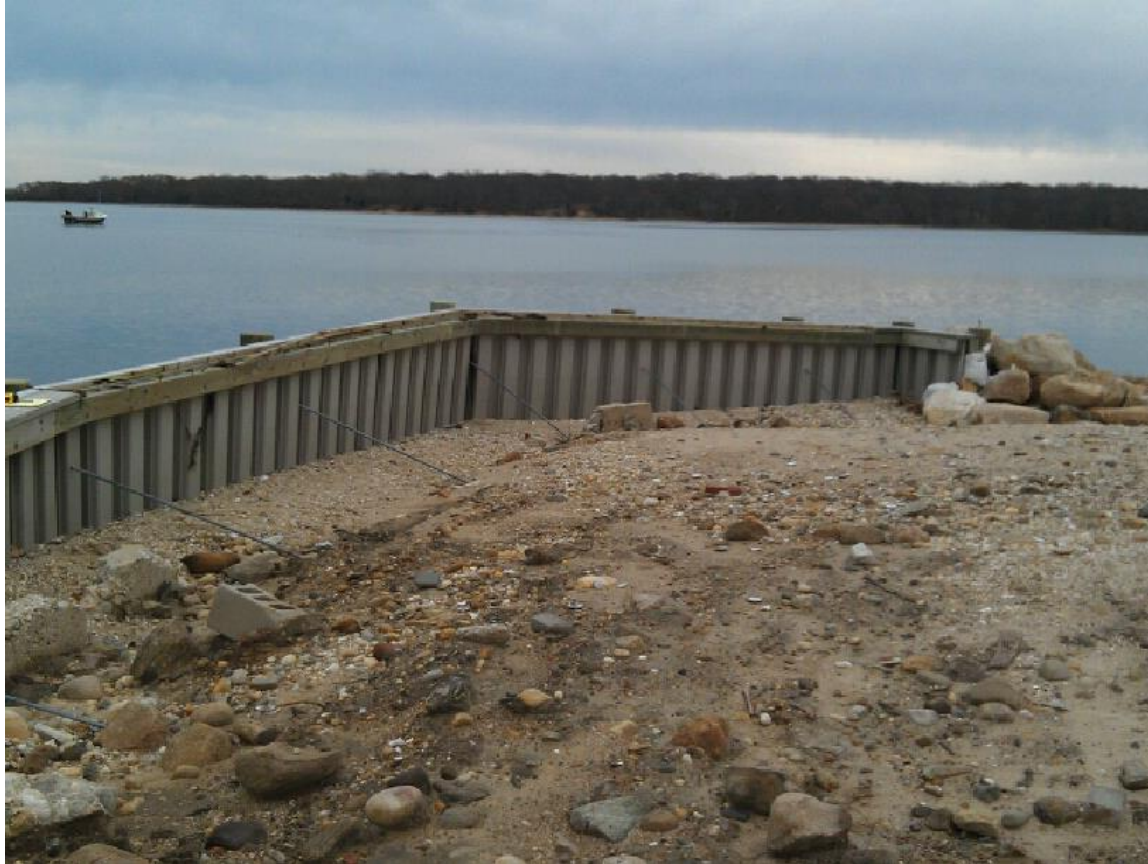
Bulkhead jacked out of position, eastern Long Island

This bulkhead was completed less than a year ago. The failure involved wave action under the top cap that jacked the bulkhead out of place until the cap failed and breaking waves could now vent.

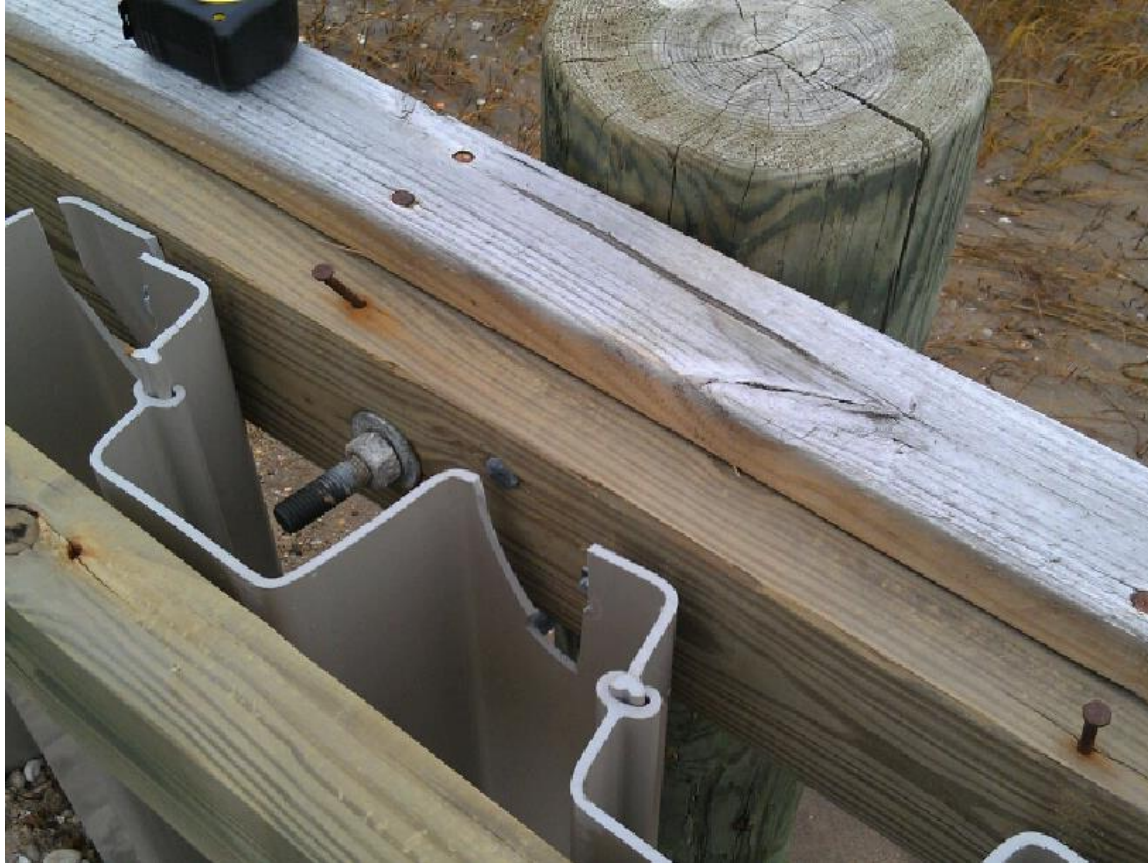
Same bulkhead, cap detail

Top cap has broken away from wave action, but not before jacking the bulkhead out of place and breaking connections to the sheet piling.

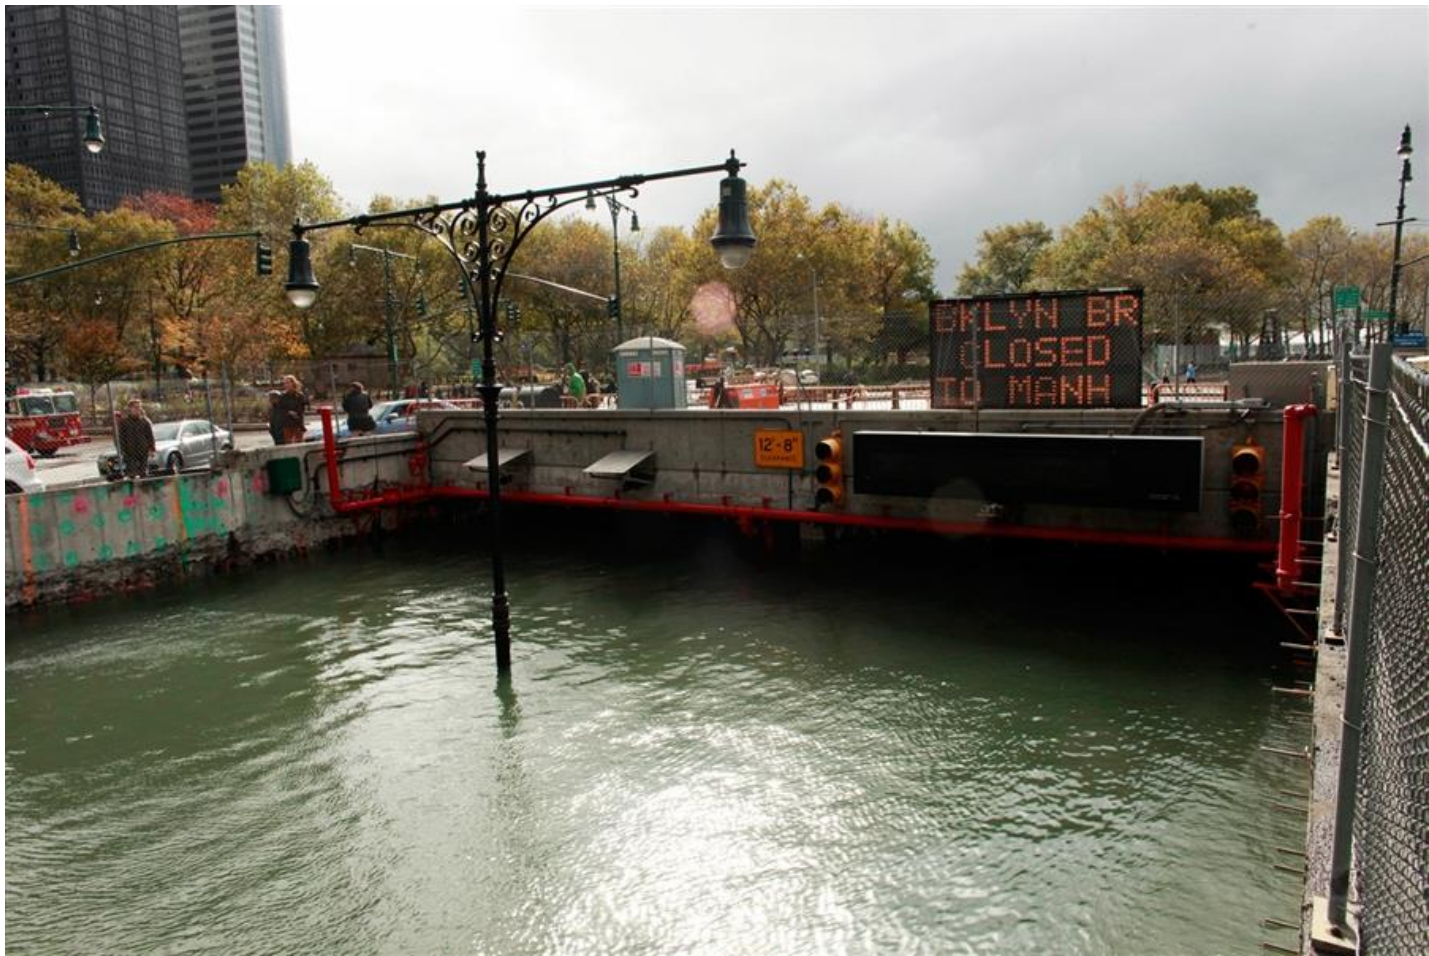
Entrance to the Brooklyn Battery Tunnel

The southern end of Manhattan is connected to Brooklyn (NYC boroughs) by the Brooklyn Battery Tunnel. The storm surge flooded the tunnel.

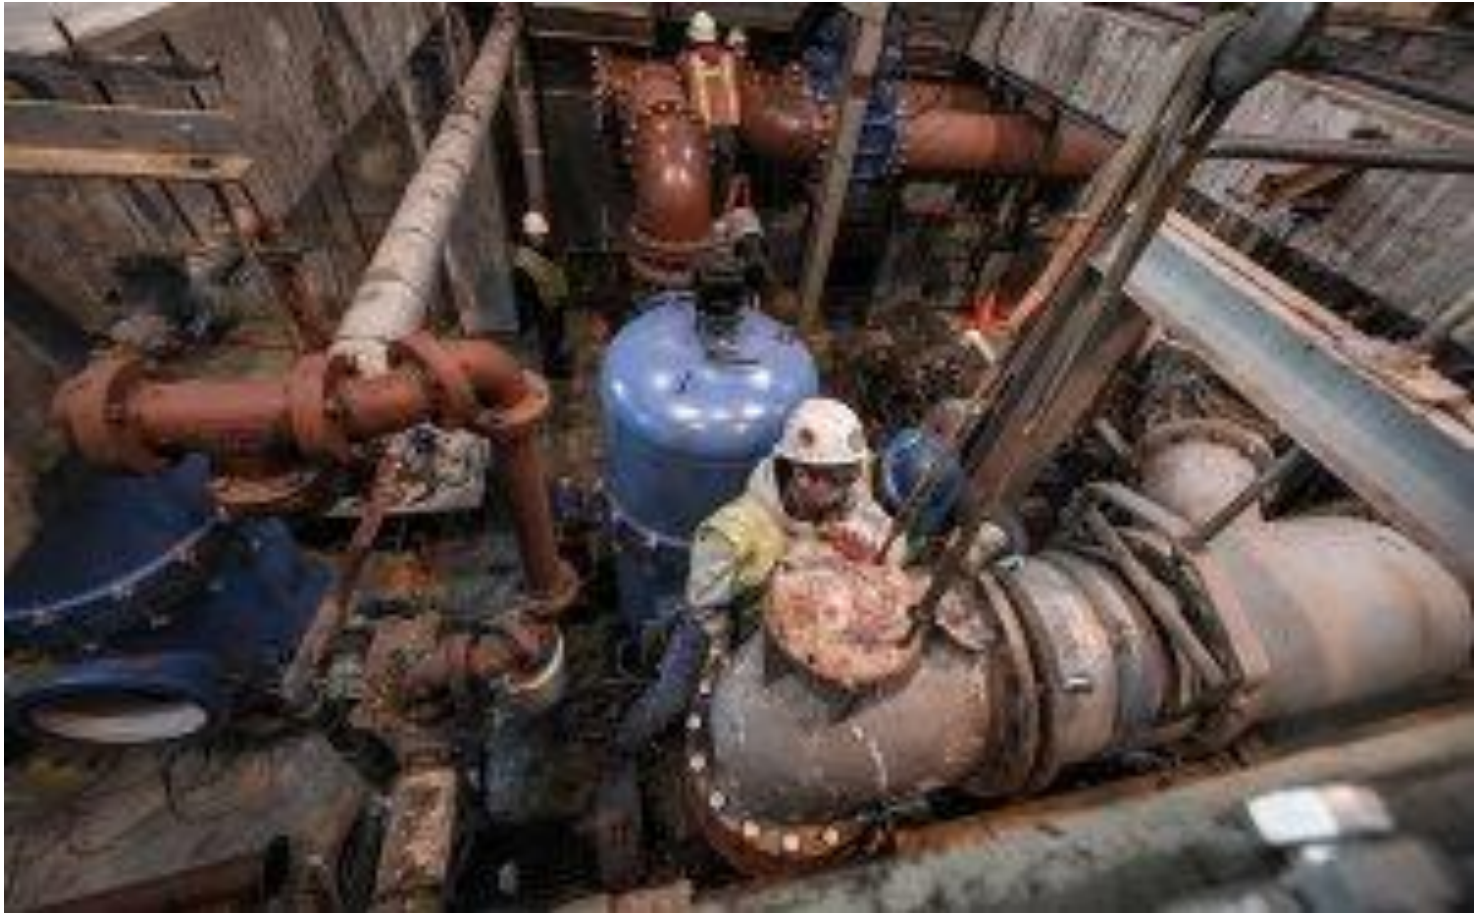
Bay Park Sewage Treatment Plant Damage

A Nassau County sewage treatment facility was rendered off line from the storm surge when flood waters entered the plant and devastated sewage pumps.

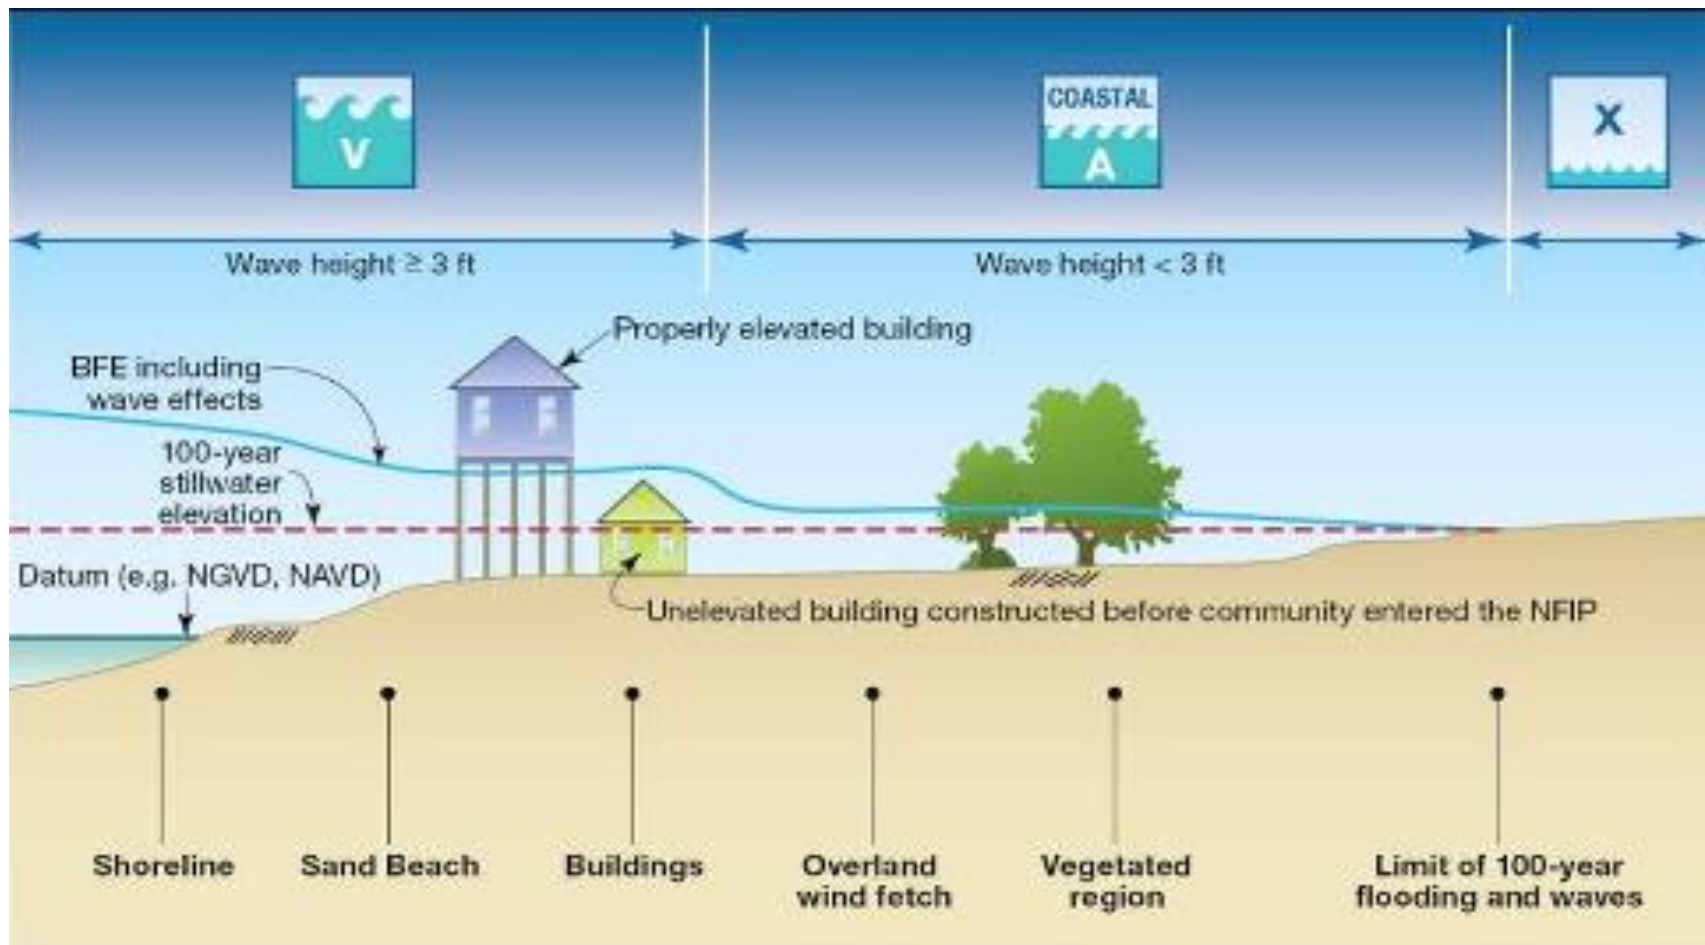
V and A zone base flood elevation concepts

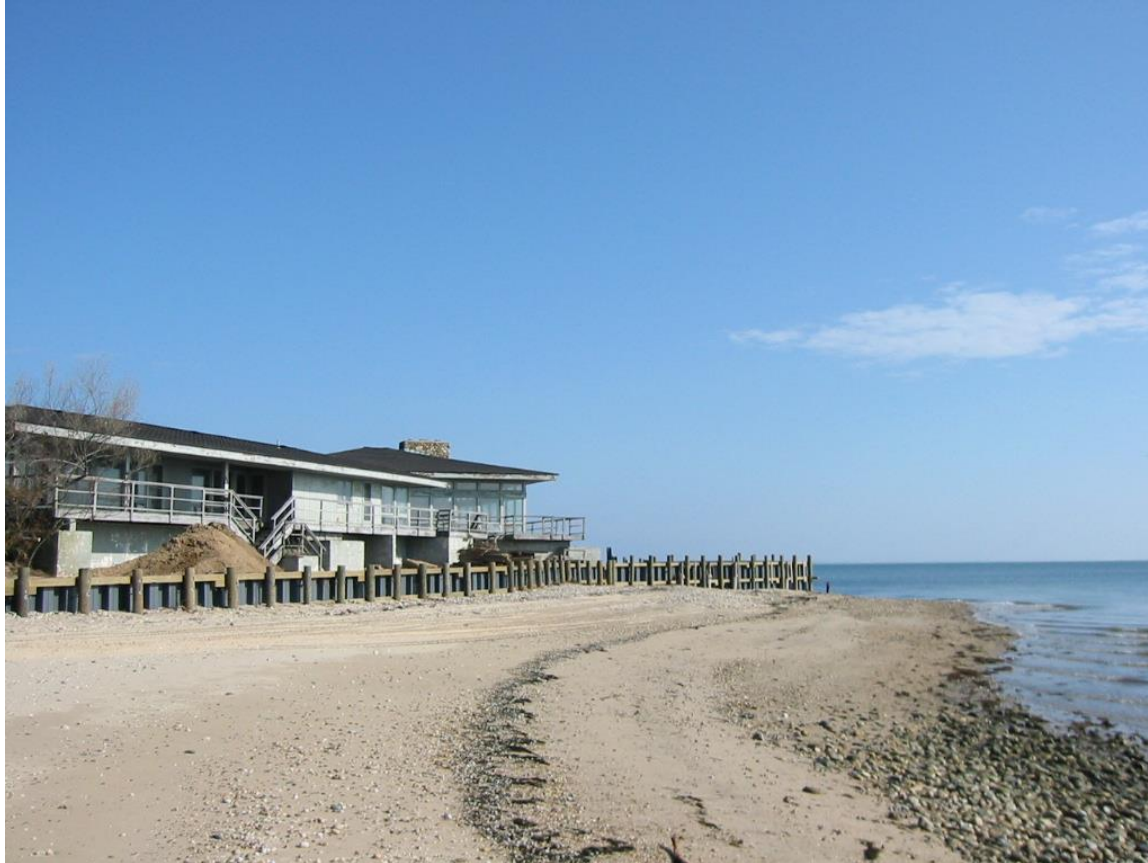
Northeast facing home on beachfront

Recall this previously shown slide? This residence is located in a VE zone with an elevation of 13 feet.

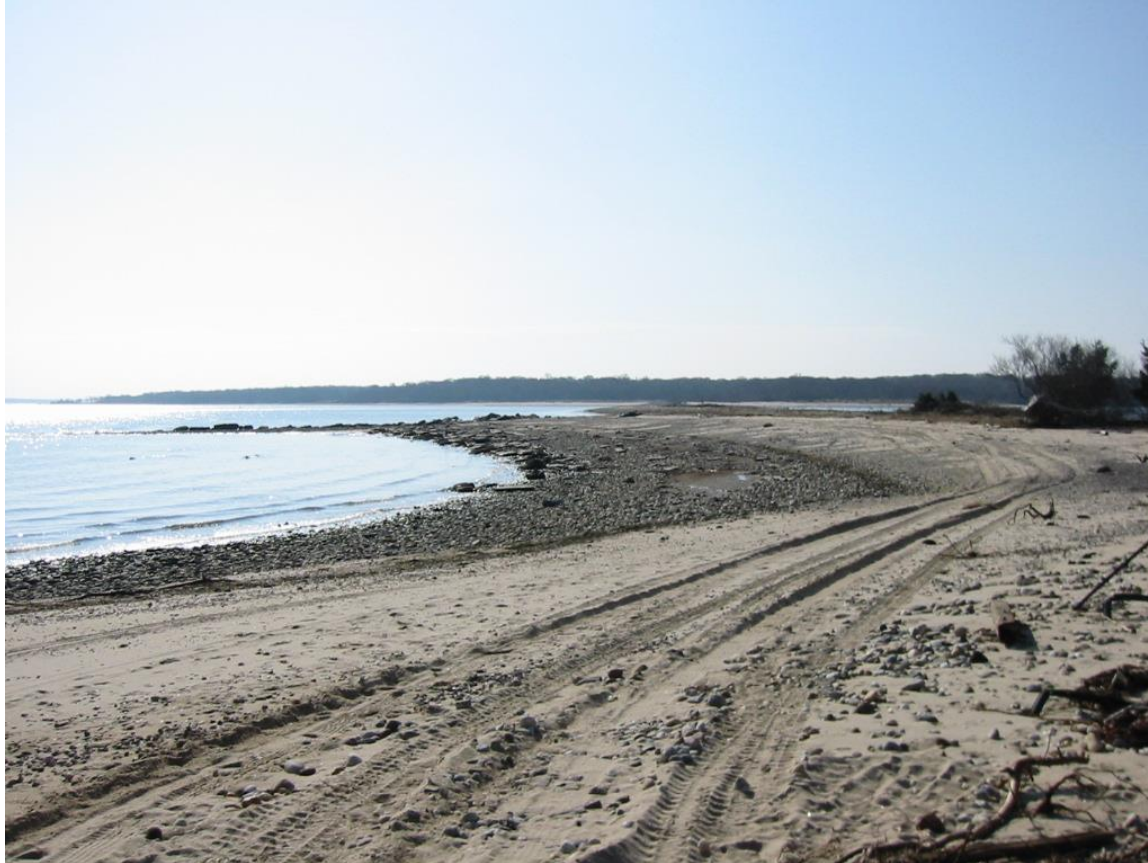
This is the point of land earlier discussed applicable to the previous slide

Storm surge effects must also be considered for protective barrier beaches. This barrier is also in a VE zone with an elevation of 13 feet.

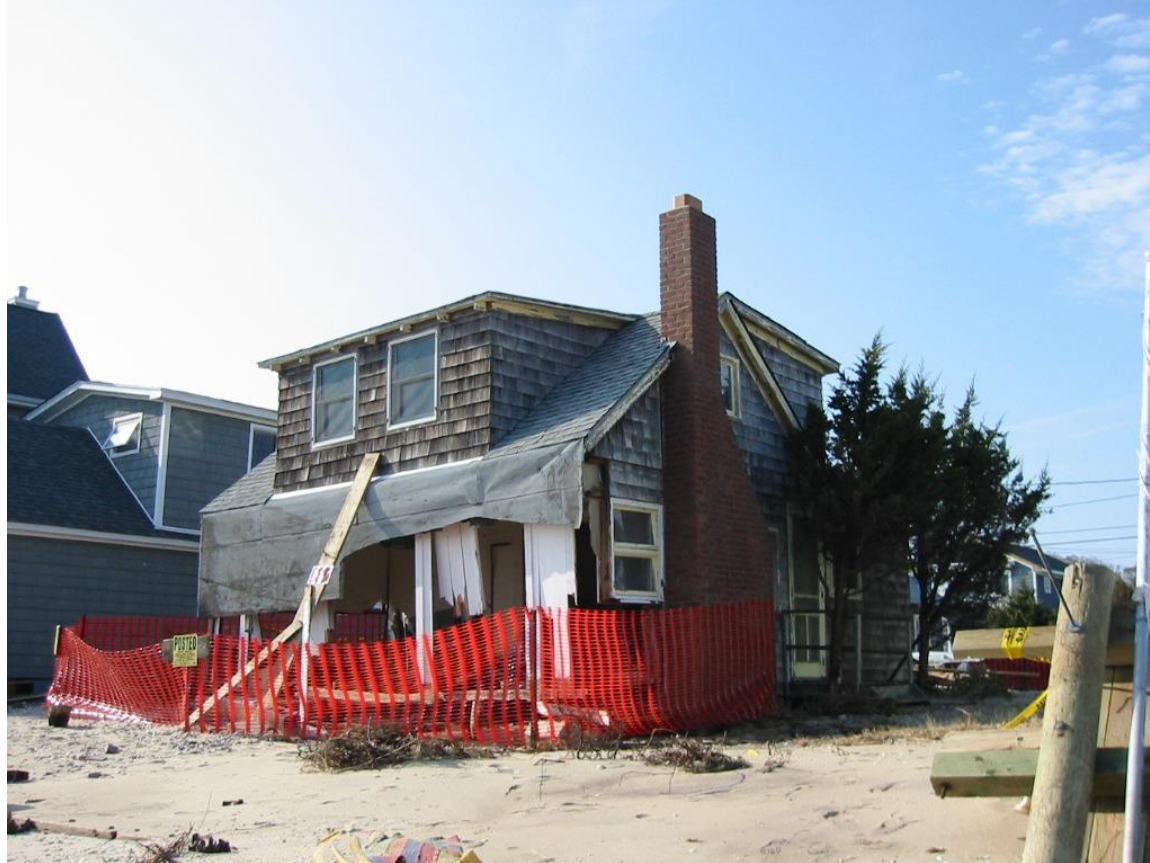
Waterfront home in East Marion, Long Island, NY

Another example of a building situated in a VE zone with elevations estimated in the range of 9 to 12 feet, and incapable of withstanding the effects.

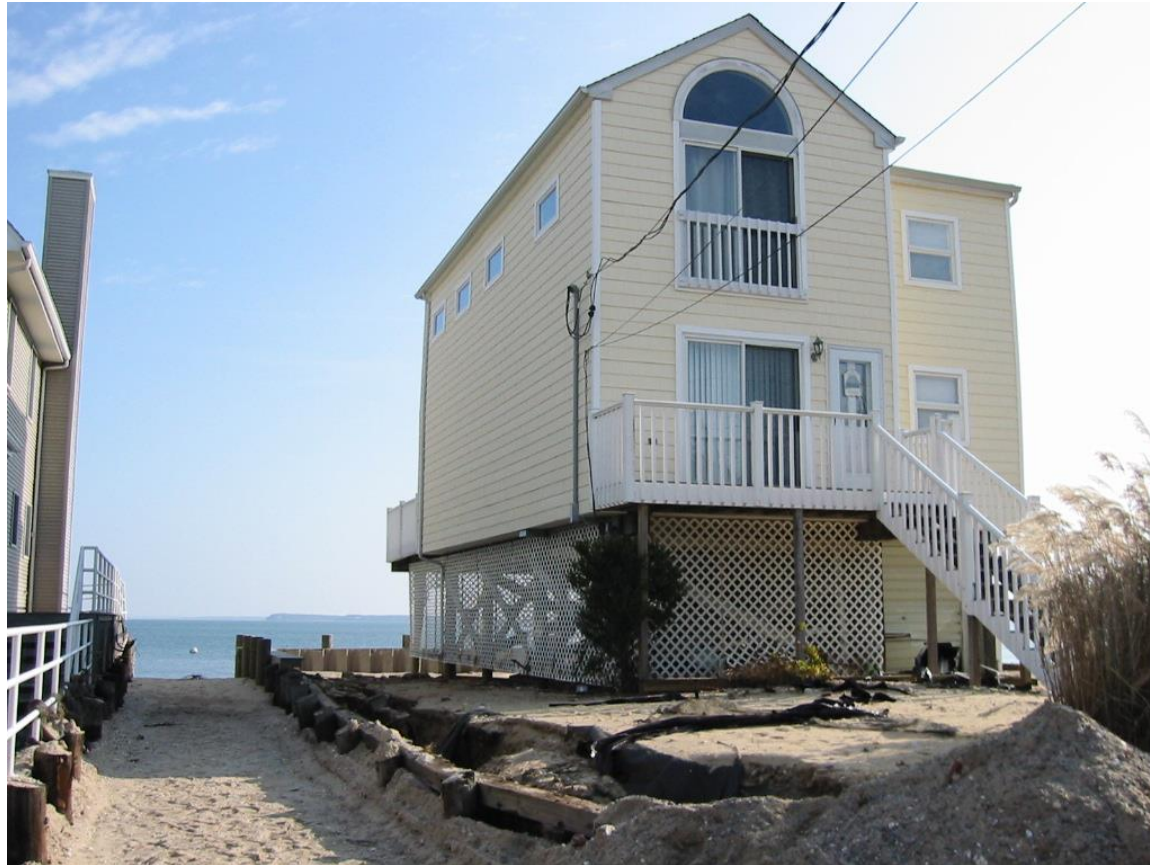
Another home in the same area

This home, in the same VE zone with elevations estimated in the range of 9 to 12 feet, had survivability.
