HURRICANE SANDY

2013 Annual Building Inspection Engineering Conference

National Academy of Building Inspection Engineers

John C. Cronin, Jr., P.E., SECB, CBIE, F.NABIE

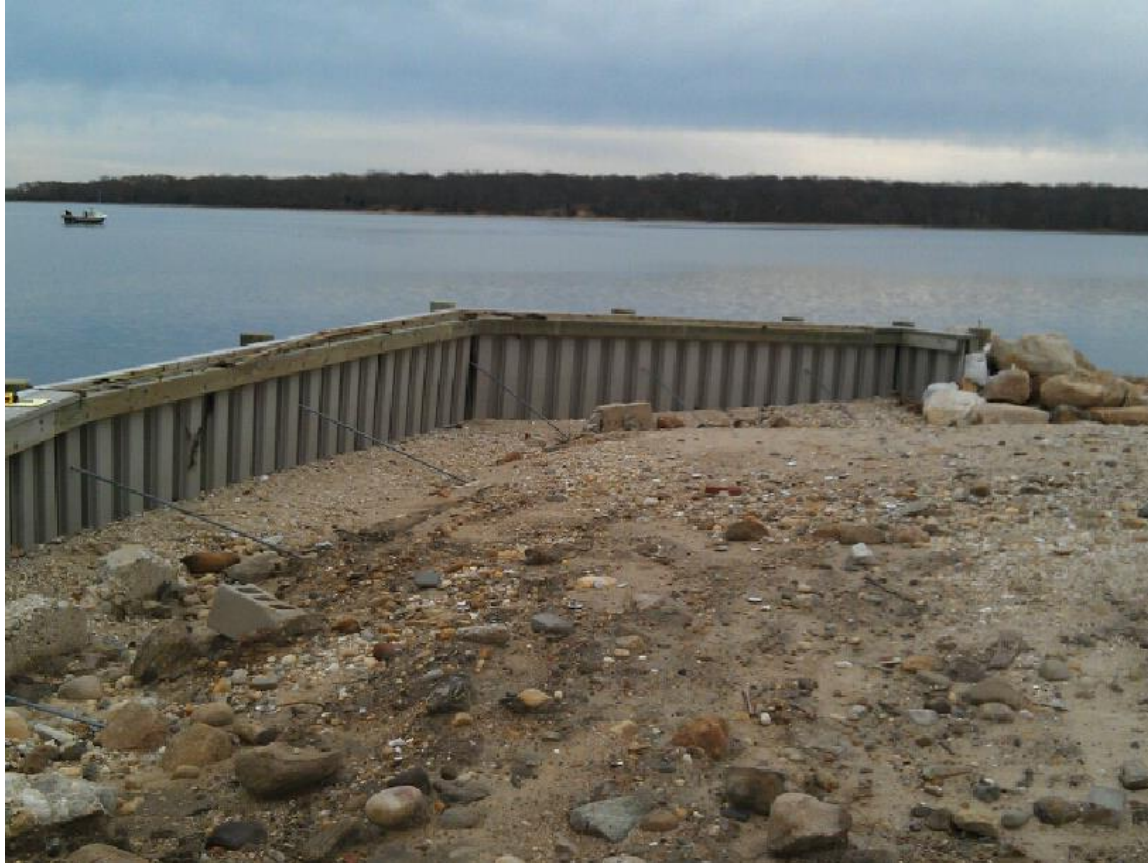
Bulkhead jacked out of position, eastern Long Island

Earlier we examined this slide and the resulting damage from storm surge. Now we can report that it is in a VE zone with an elevation of 10 feet.

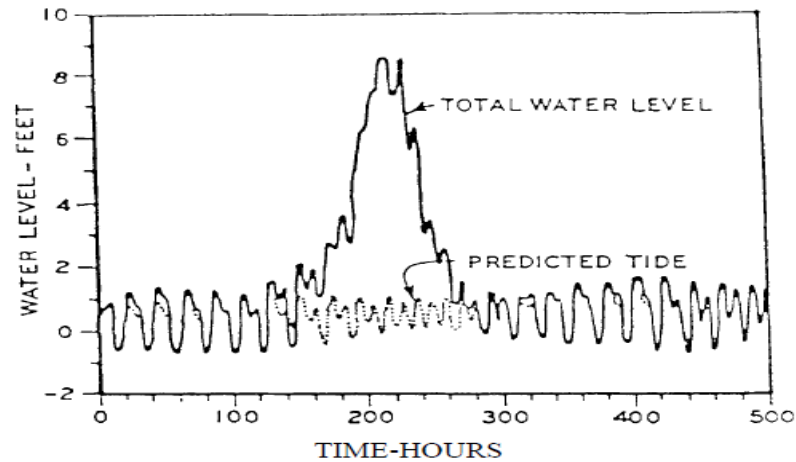
a. Observed total water level and predicted tide

b. Surge obtained by extracting predicted tide from total water level

The storm made landfall around 1400 hours on 9/11, about 252 hours after the surge clock started, yet peak surge occurred at about 210 hours.

Figure 1-3. Water level variations during Hurricane Carla (1961) at Pleasure Pier, Galveston, Texas.
