# NABIE THE Examiner

## Building for Tornadoes

# Transition and the Reserve Study

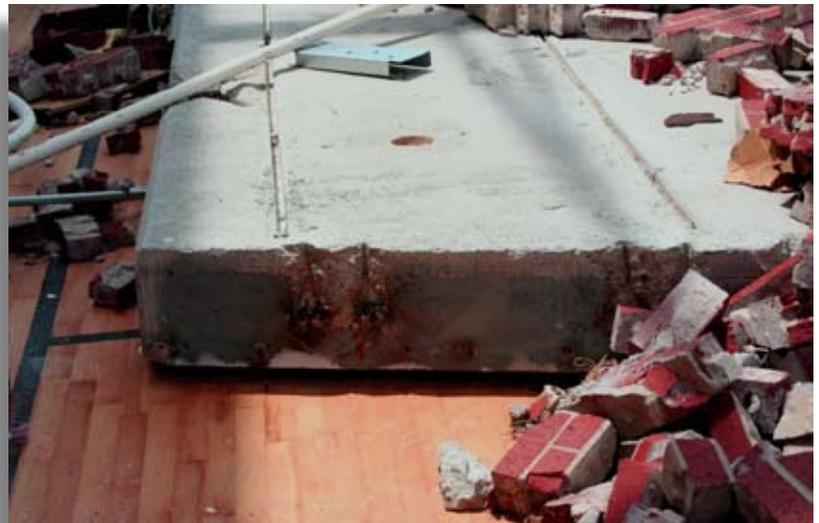
*Puddle welded connection on top of wall failed*

Many of the failures of the older buildings can be attributed to the lack of continuous vertical and/or lateral load paths, not just too excessive wind speeds. In a series of perpendicular transects to the tornado's

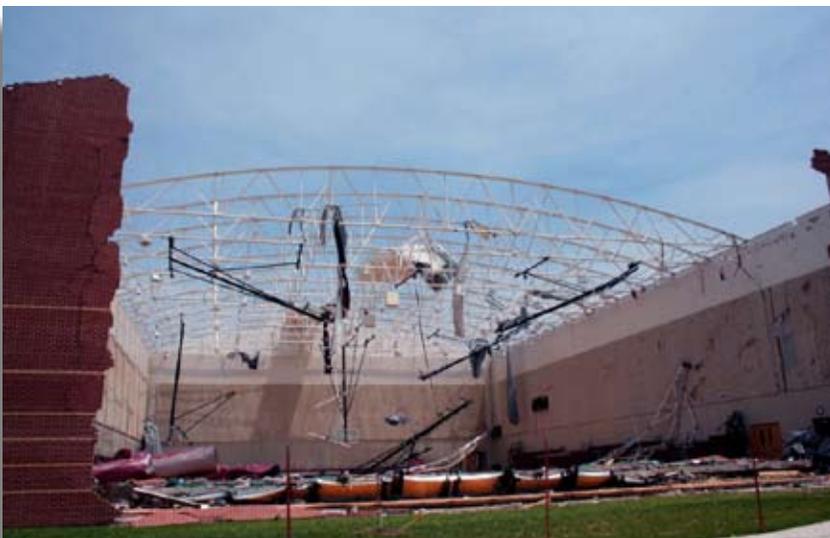
*Exterior wall collapsed – no connection at footing*

The study team found numerous examples in load path failures where detailing in compliance with current building codes for hurricane-prone regions would have reduced the damage and potentially reduced injuries. Unfortunately, some of these discoveries were in school buildings, two built within the last 10 years. These examples included a lack of physical attachment of precast concrete walls to footings or to adjacent wall panels (Figure 1), insufficient attachment and no redundancy in the support of metal bar joist roof framing systems into load bearing walls, and the lack of adequate lateral support at the top of exterior walls (Figure 2). The team also observed frequent failures in masonry infill walls where there was no or minimal

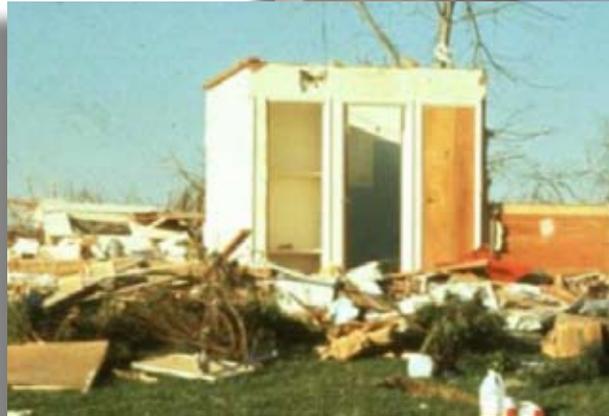
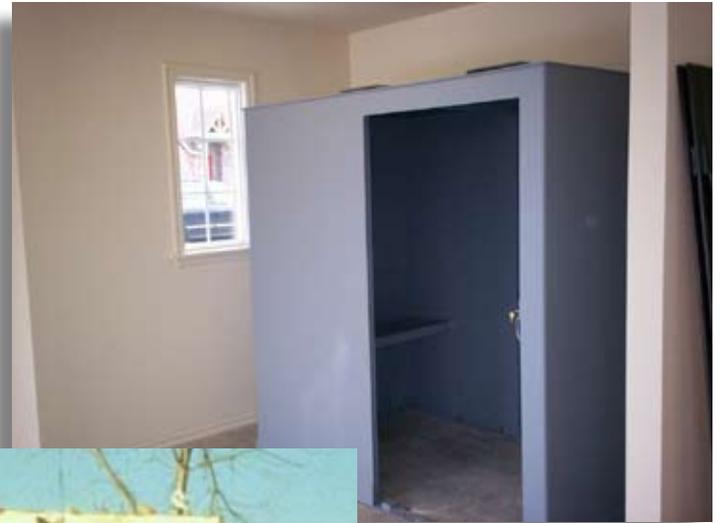
*Safe room shelters*

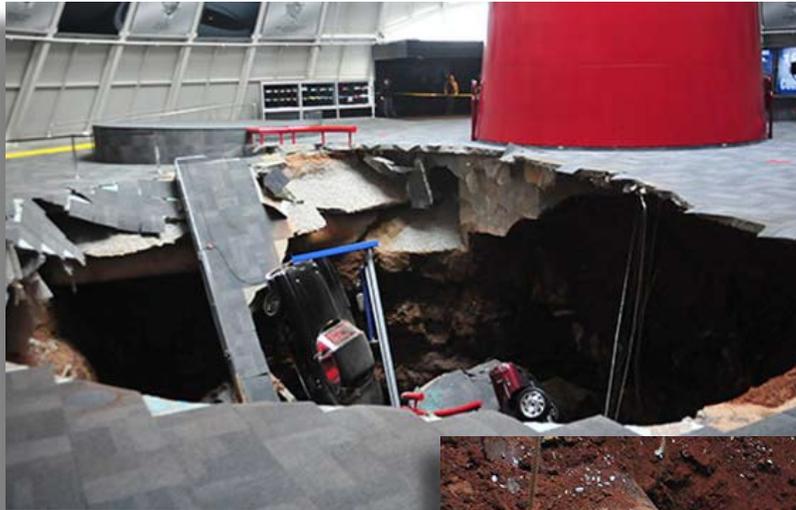
Eight valuable 'vettes at Bowling Green, Kentucky's National Corvette Museum fell victim to a 40-foot-wide, 20-foot-deep sinkhole that opened up in the facility's yellow Sky Dome wing. The museum unofficially estimates it caused millions of dollars in damage.

Using remote-controlled drones, geologists and engineers from nearby Western Kentucky University have already explored the sinkhole and determined that the Sky Dome suffered no structural damage, Frassinelli
